Debris/Ice/TPS Assessment and Integrated Photographic Analysis for Shuttle Mission STS-57

July 1993

Gregory N. Katnik
NASA/Kennedy Space Center

DEBRIS/ICE/TPS ASSESSMENT
AND
PHOTOGRAPHIC ANALYSIS
OF
SHUTTLE MISSION STS-57

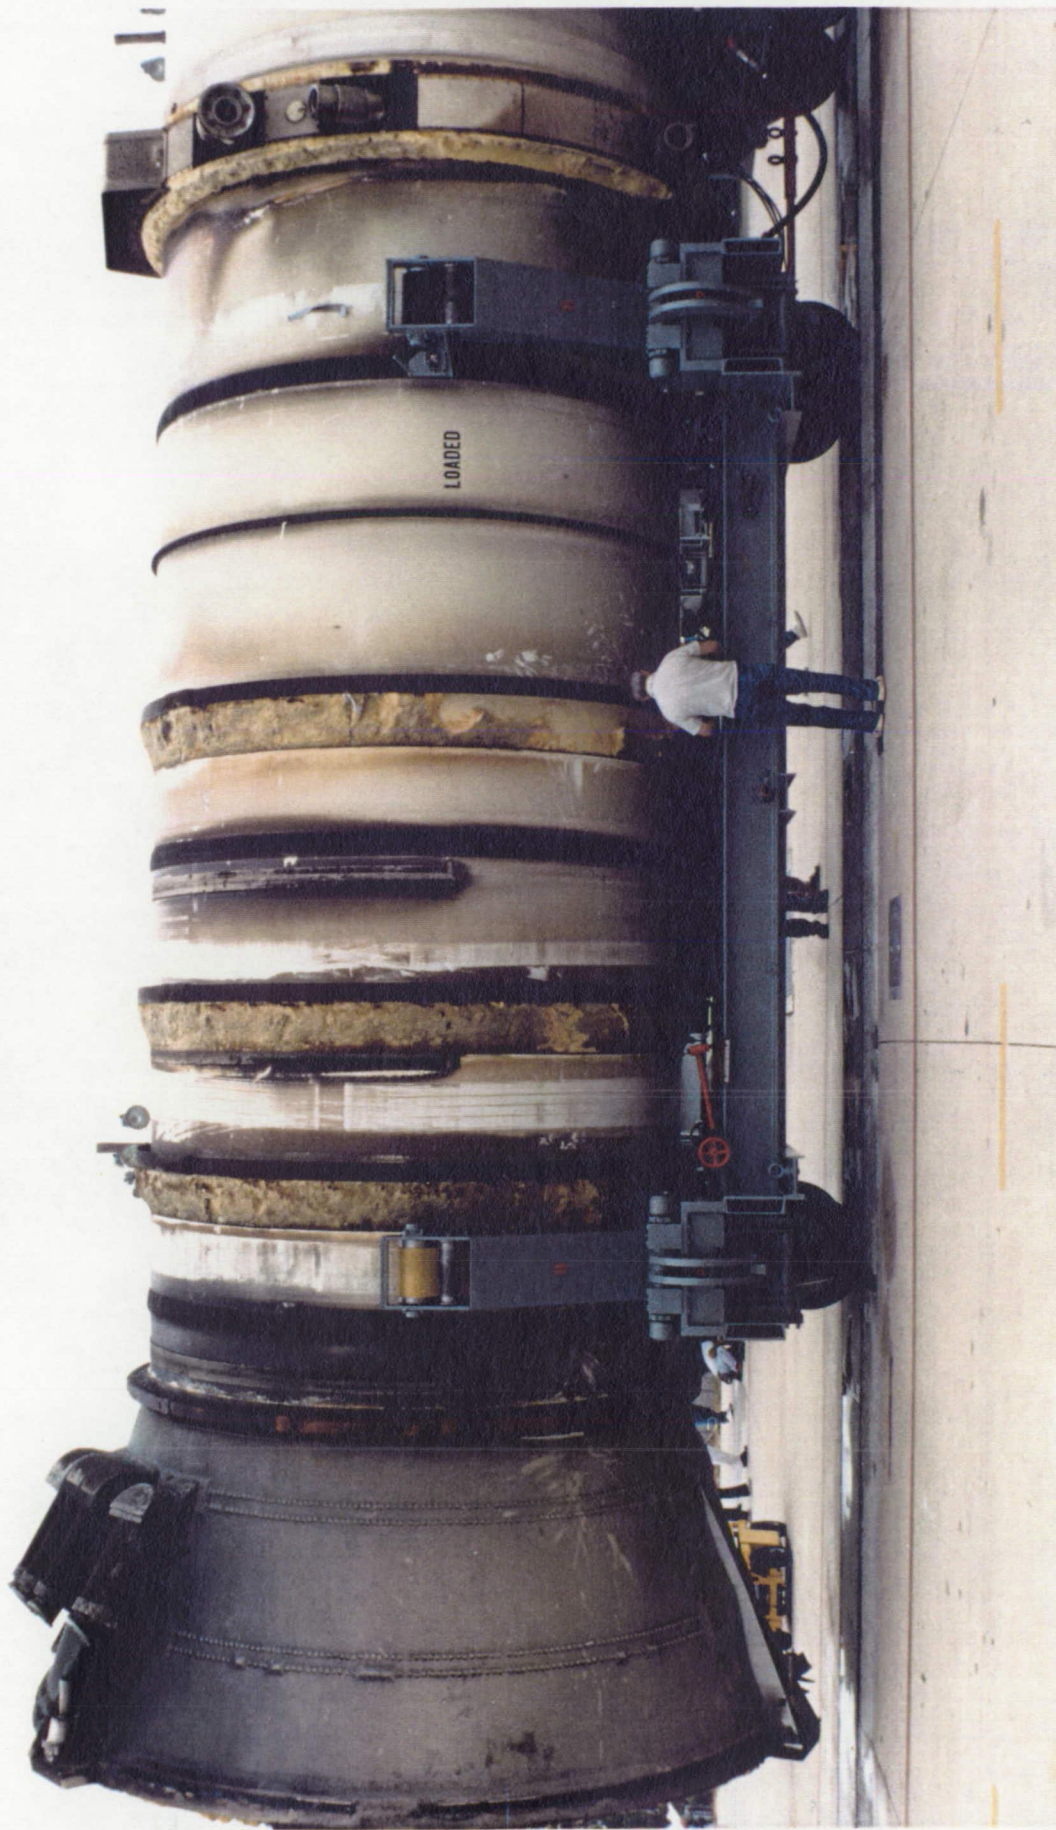
Post flight condition of the LH aft booster and aft skirt. The ET/SPB aft struts, ETA ring, IEA, and IEA covers appeared undamaged. All three aft booster stiffener rings were damaged by water impact.

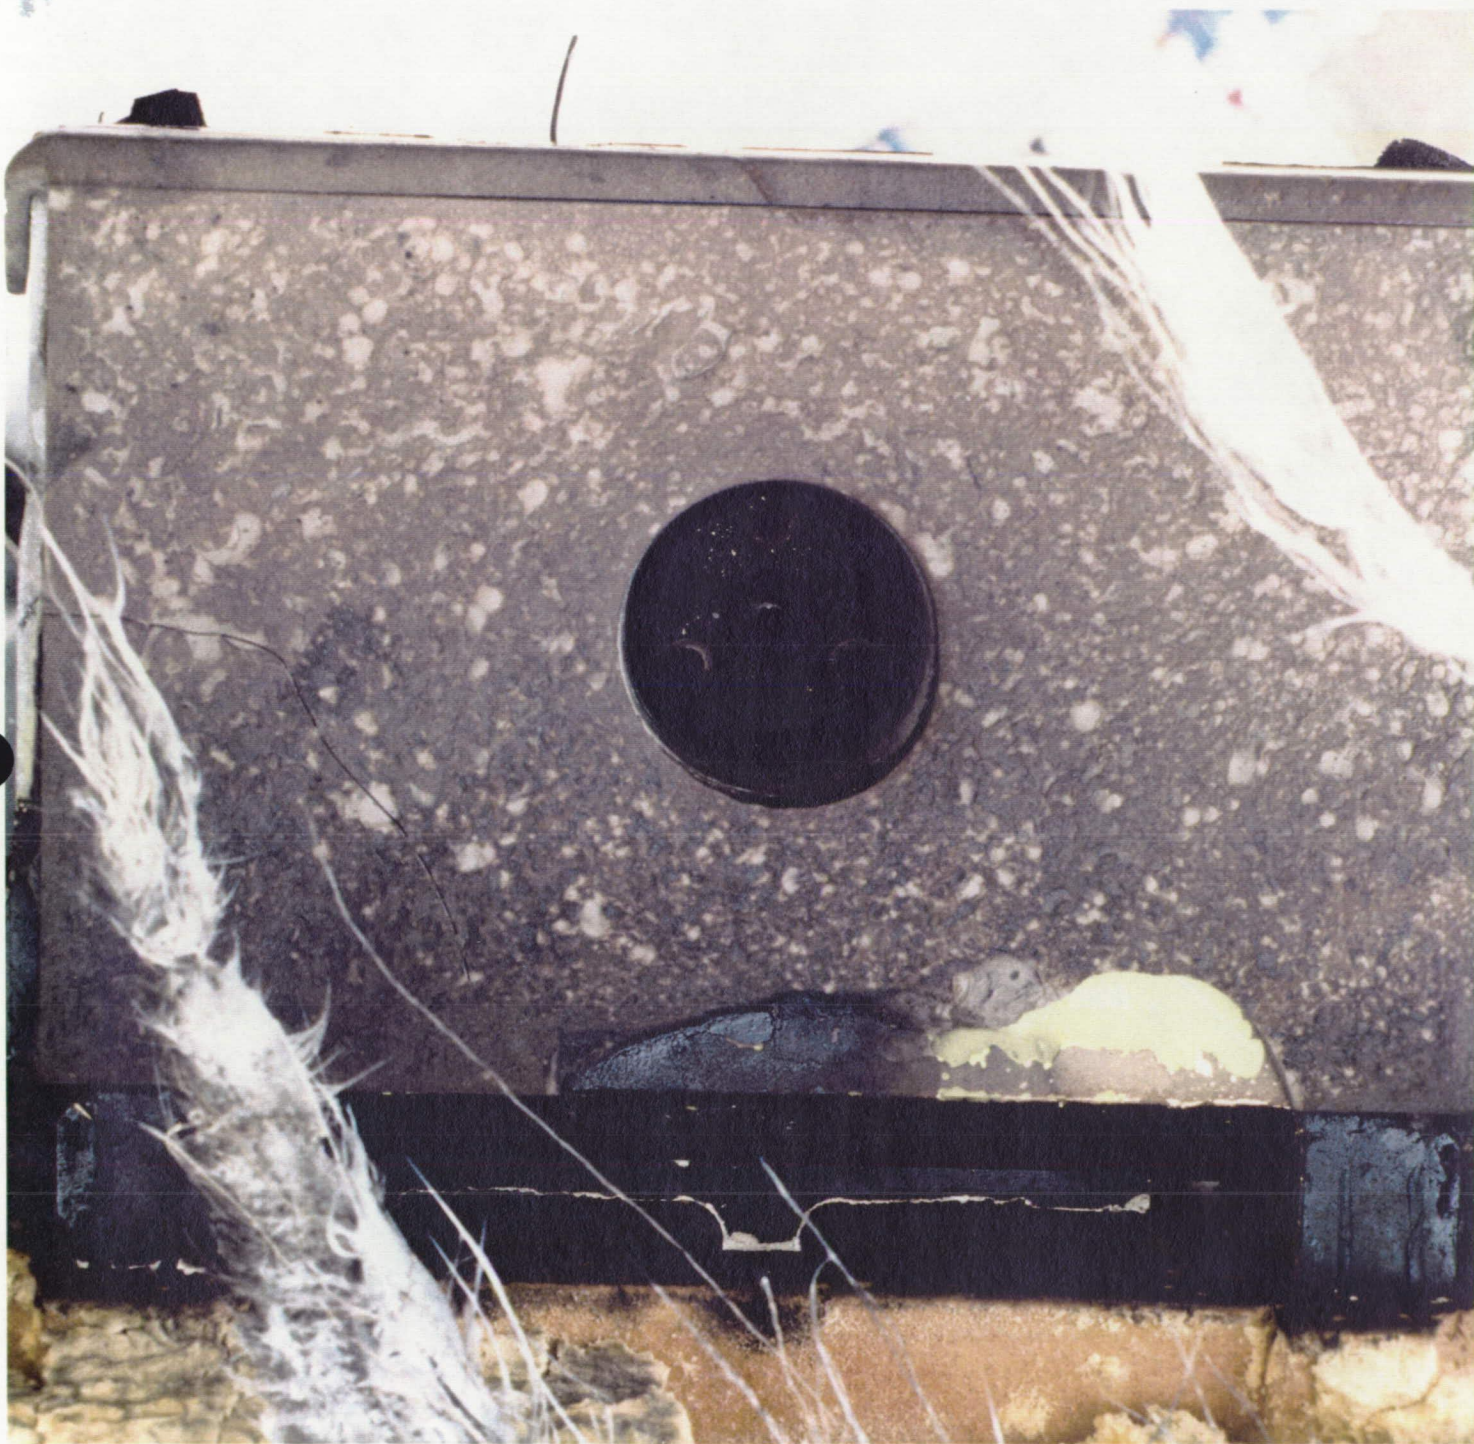
Approximately ten percent of the EPON shim material was missing prior to splashdown. The substrate was sooted.

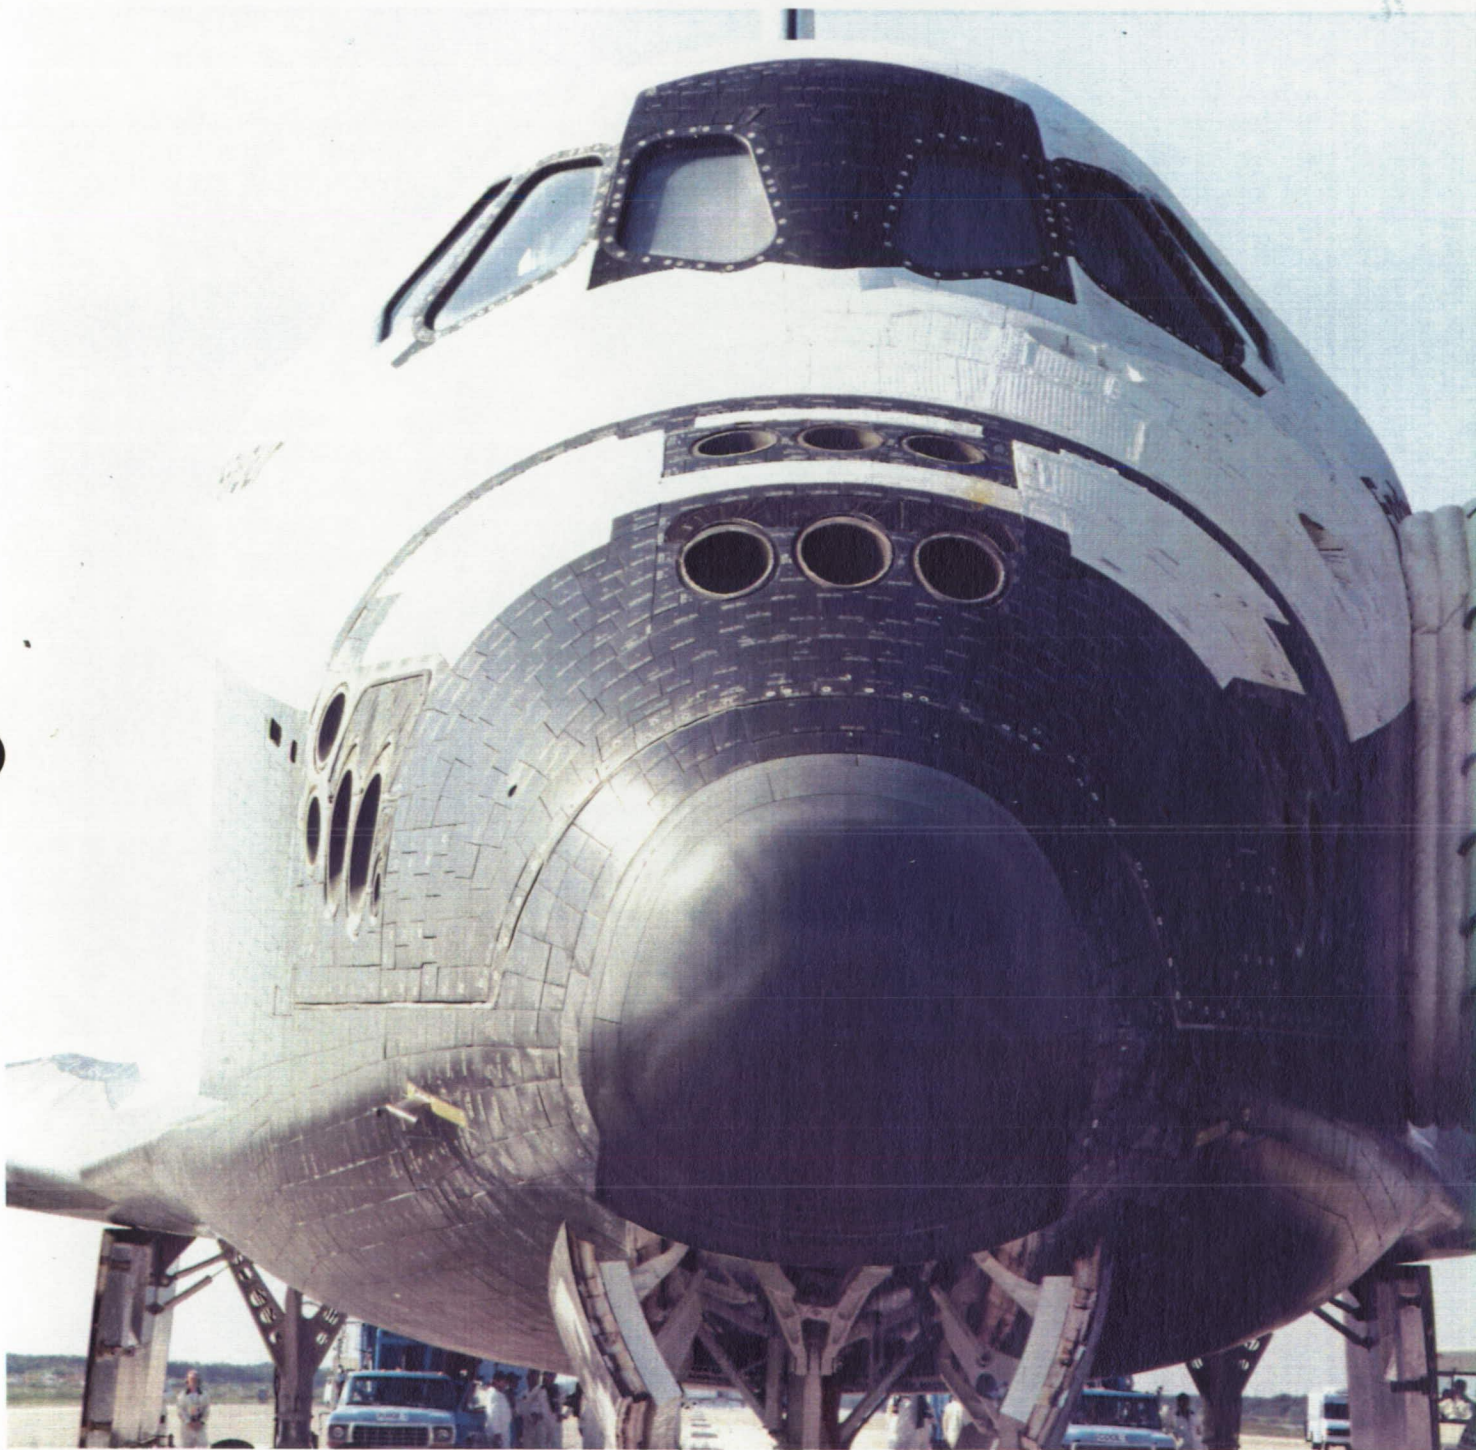
Overall view of the Orbiter nose. Forward facing windows were moderately hazed. Note discoloration of the AFRSI near the F3D and F1F thrusters.

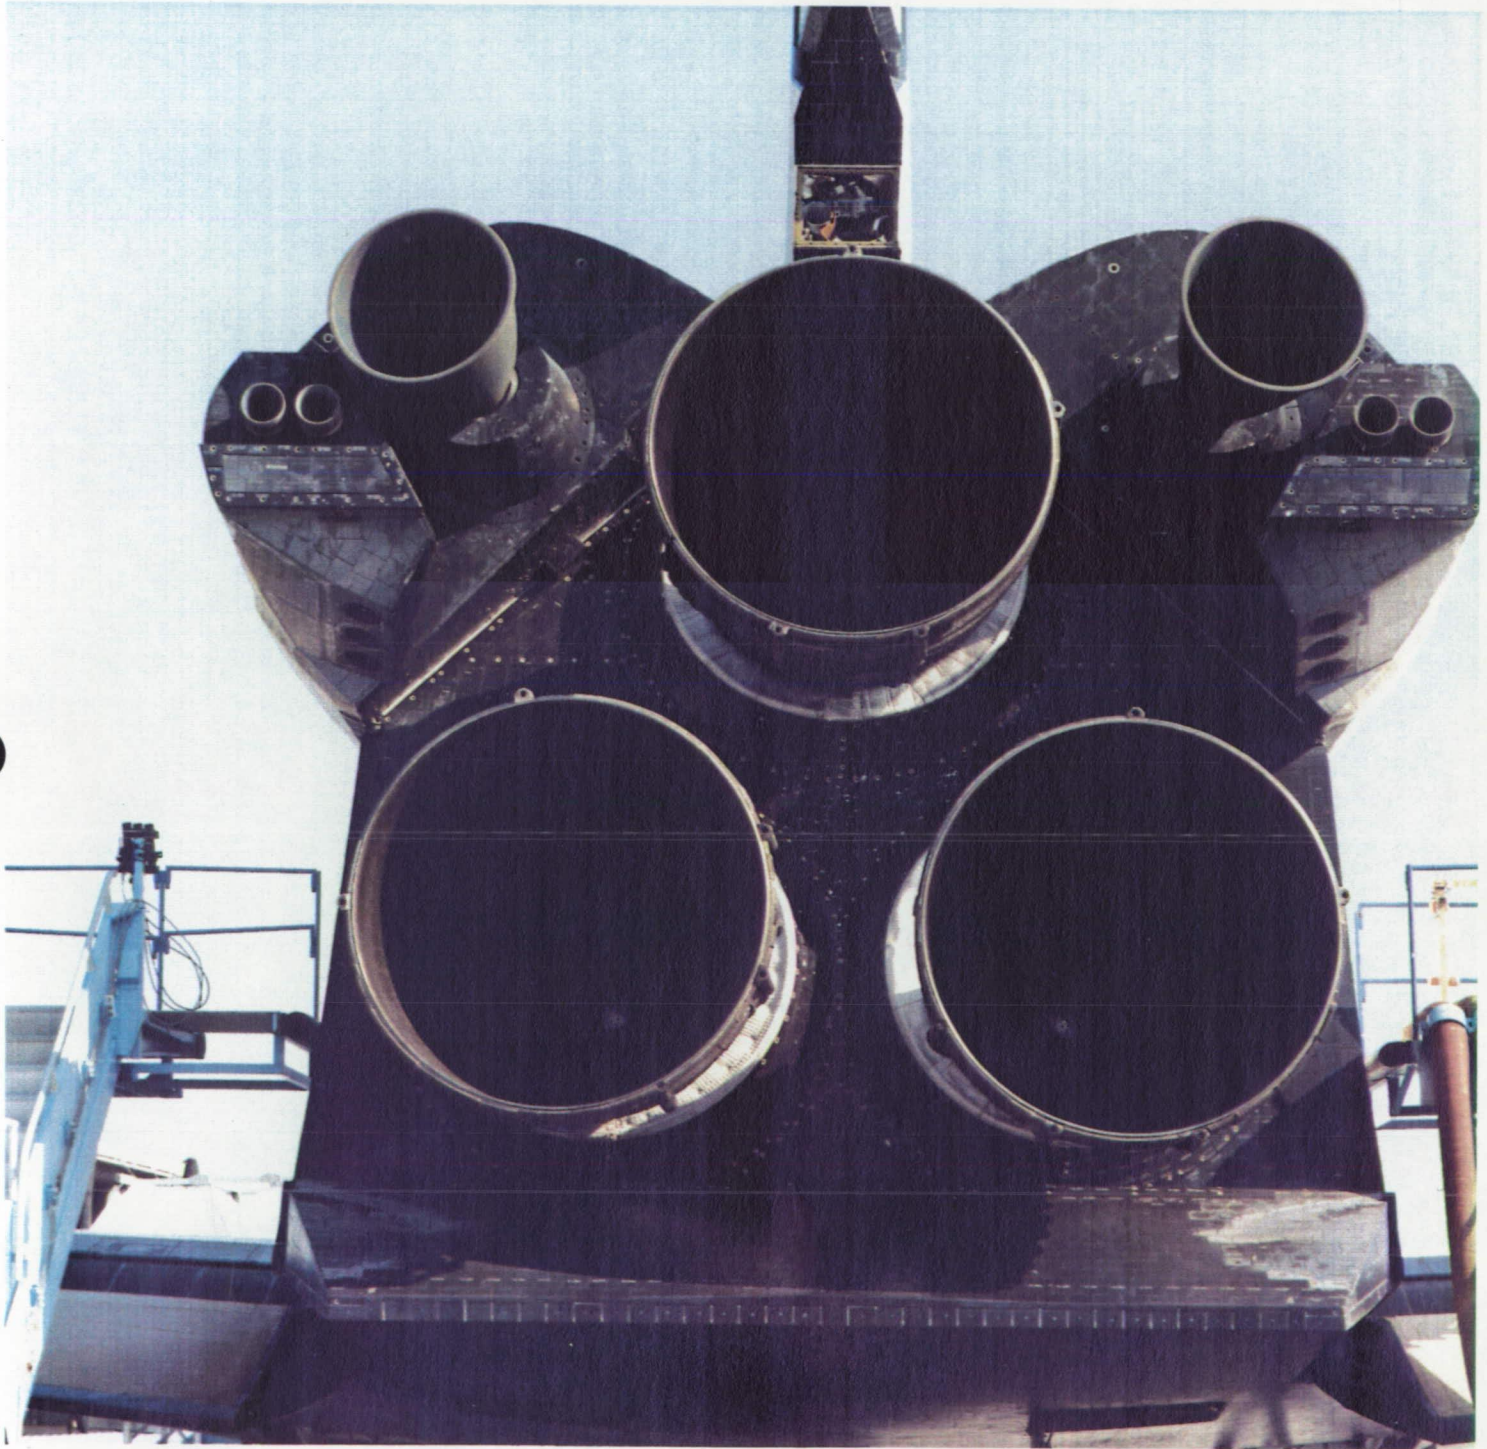
Tile damage on the base heat shield was average. The SSME Dome Mounted Heat Shield (DMHS) closeout blanket sacrificial panels were intact and missing no material.

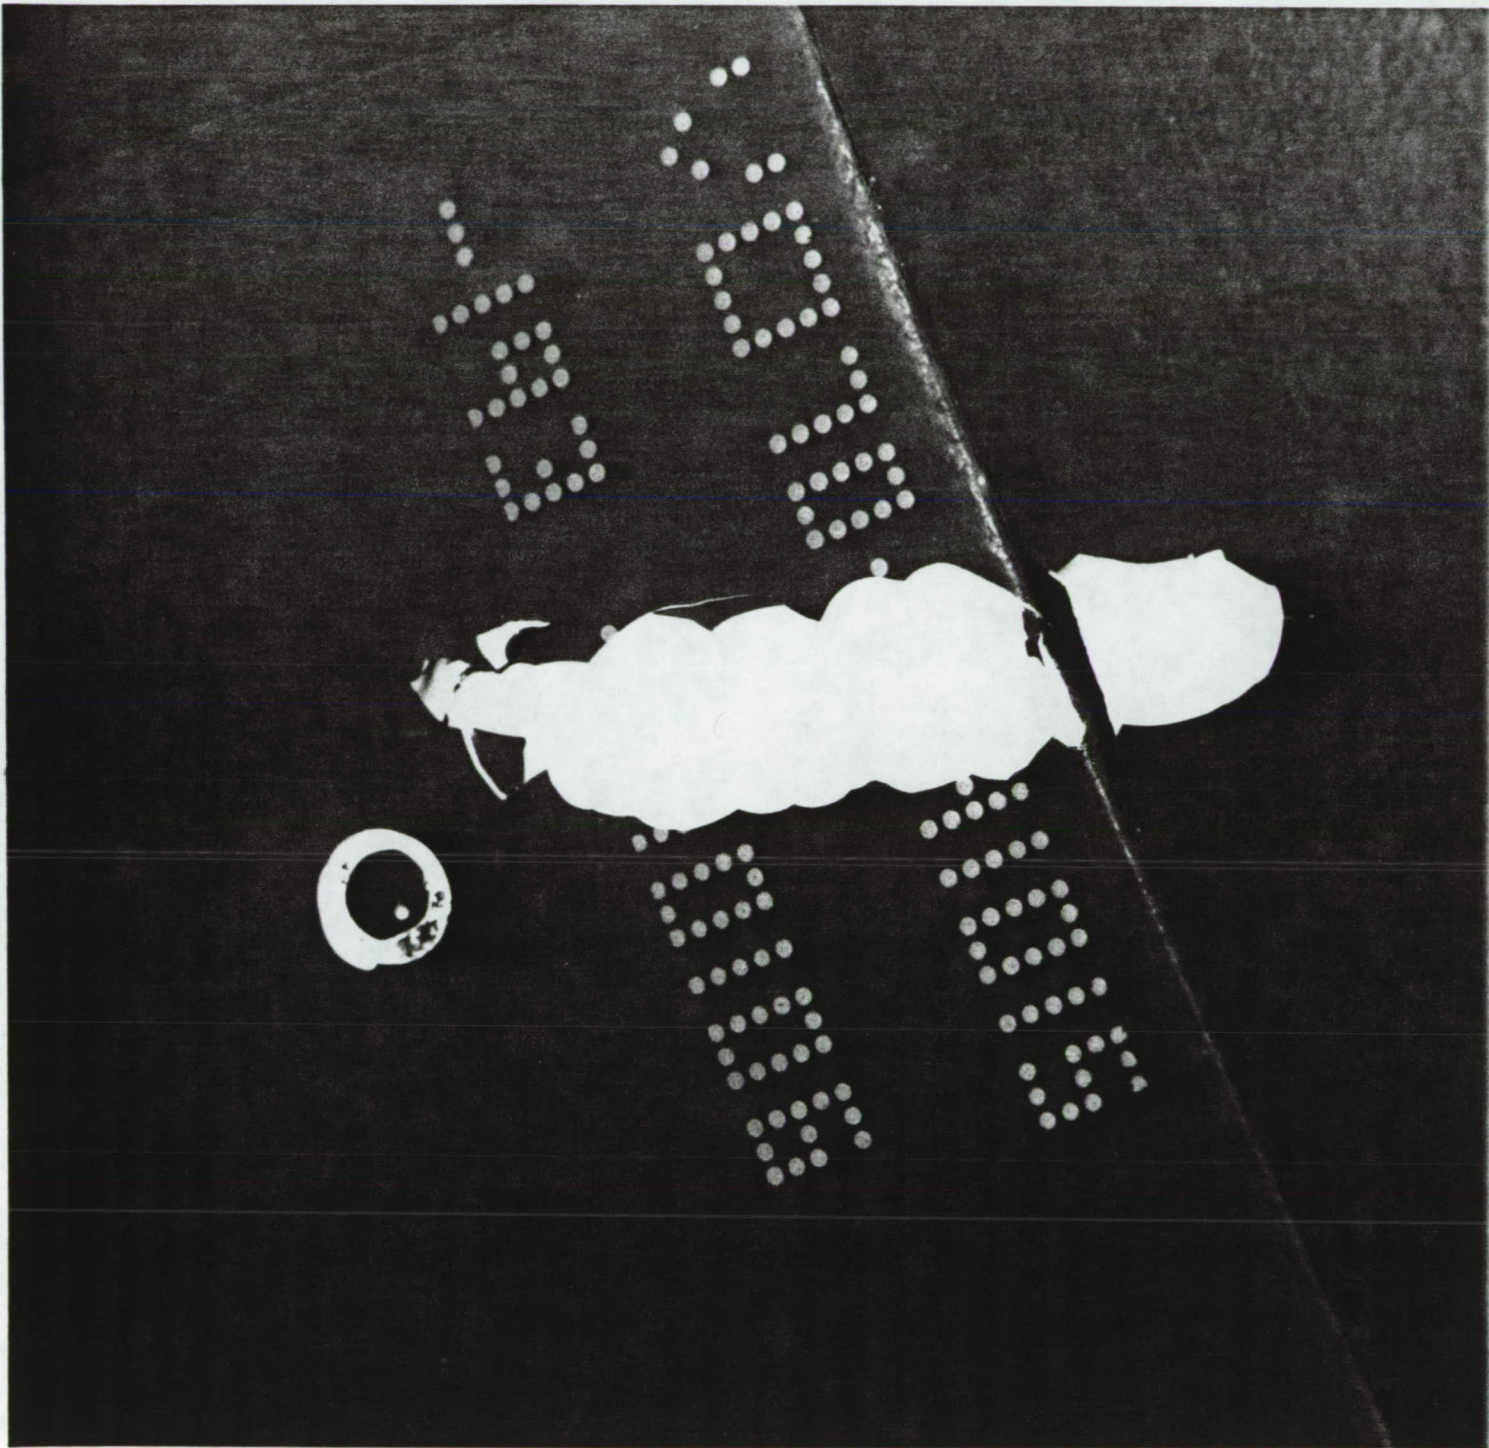
The Orbiter lower surface sustained a total of 75 hits. The largest tile damage site measured 3.5" x 0.75" x 0.375" and was located on the RH lower surface outboard of the nose landing gear door.

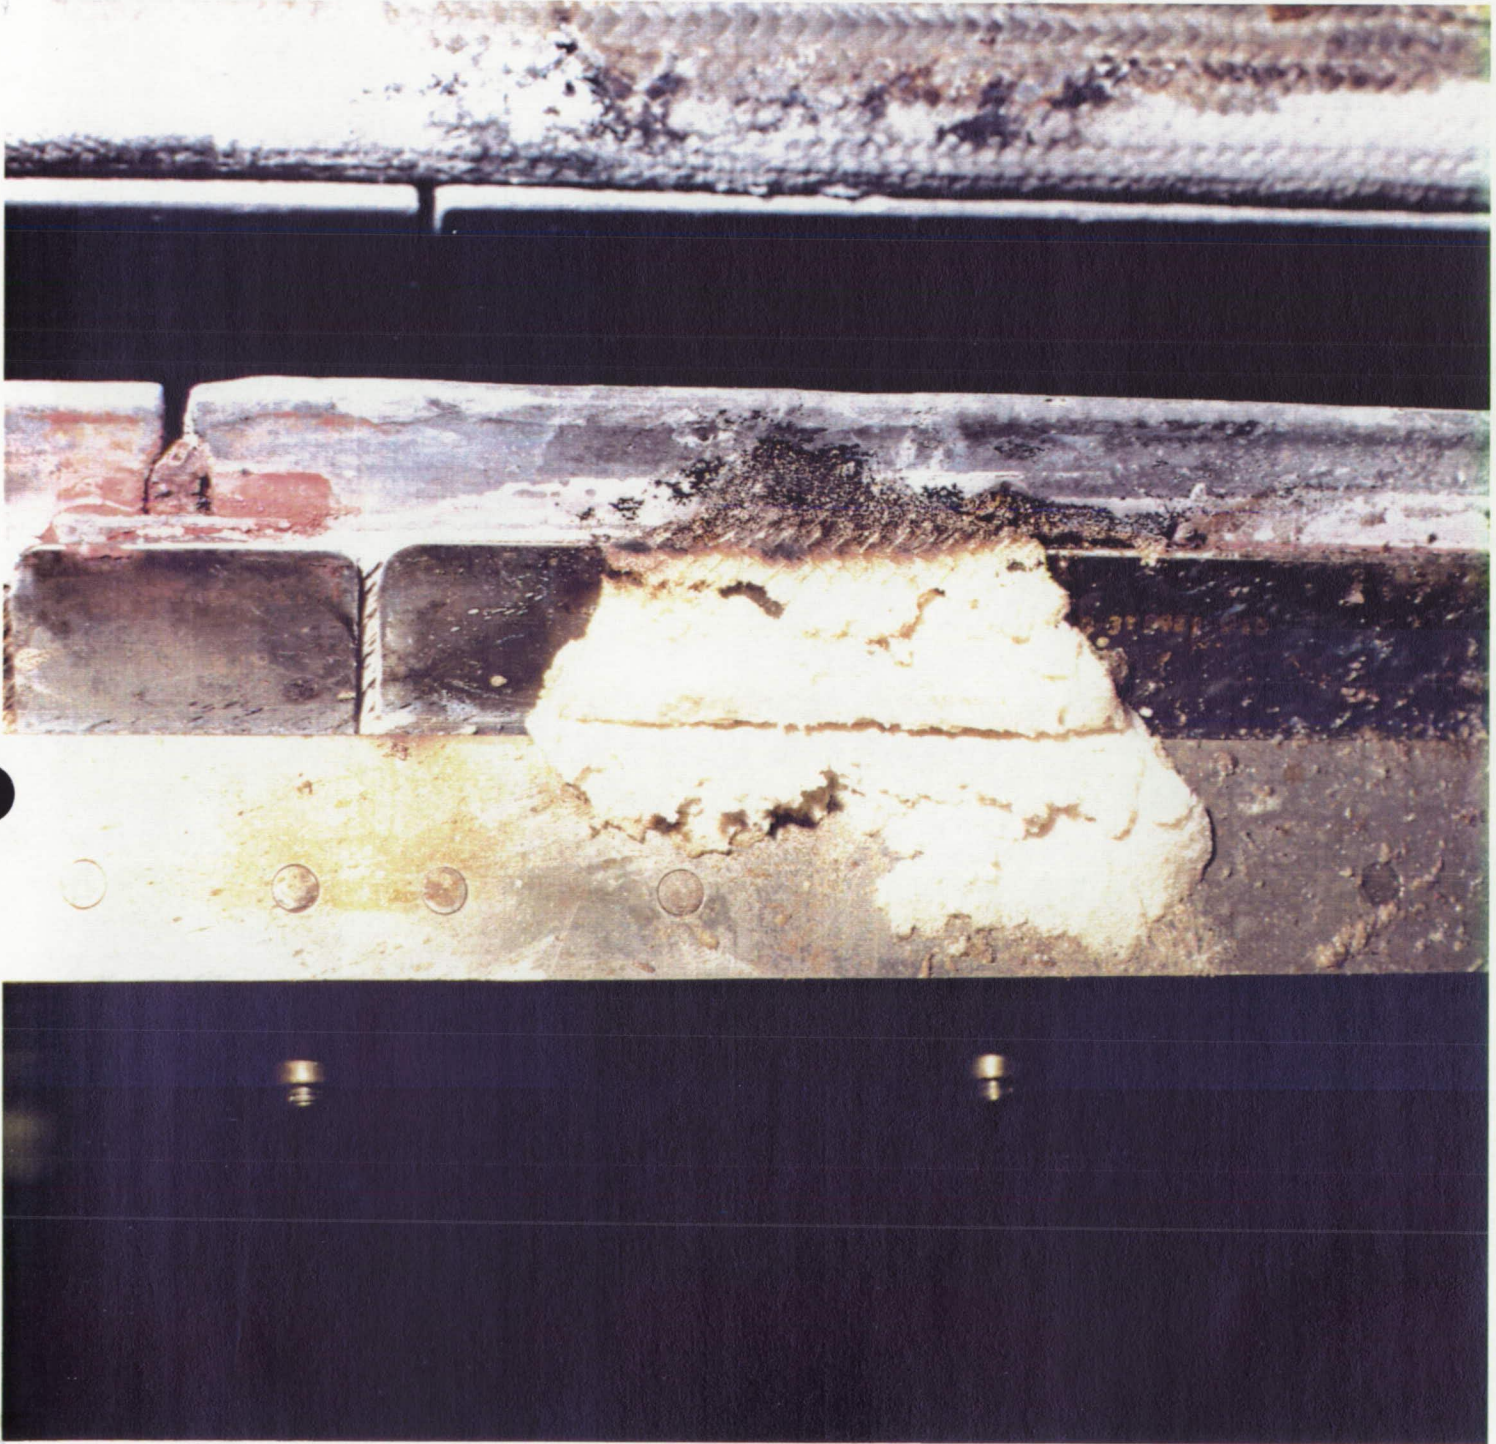
Visual inspection of the right ET door (LO2 side) revealed a 3" x 1" piece of foam adhering to a tile near the hinge line. The foam had been compressed into the thermal barrier when the door was closed, but apparently did not affect the seal.

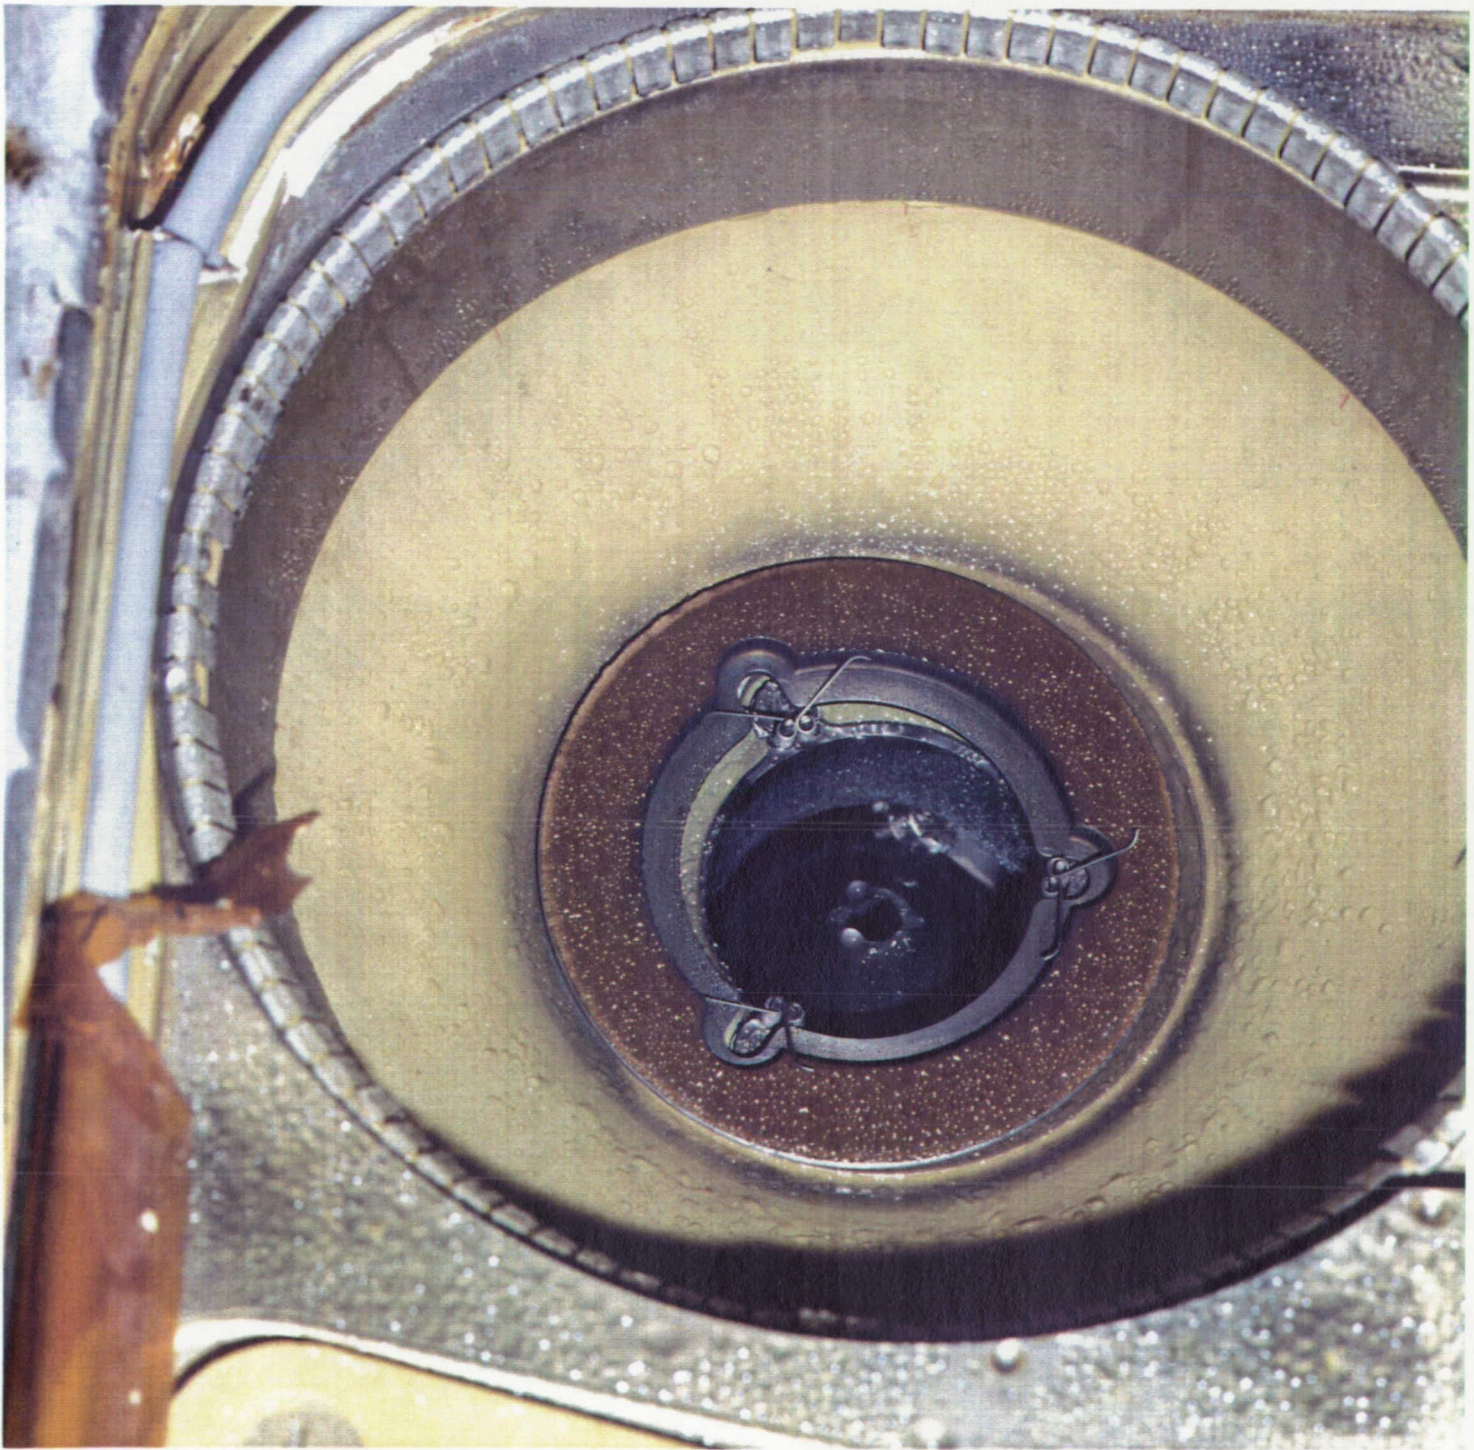
The left ET/ORB attach point (EO-2) hole plugger had not seated and was obstructed by ordnance fragments

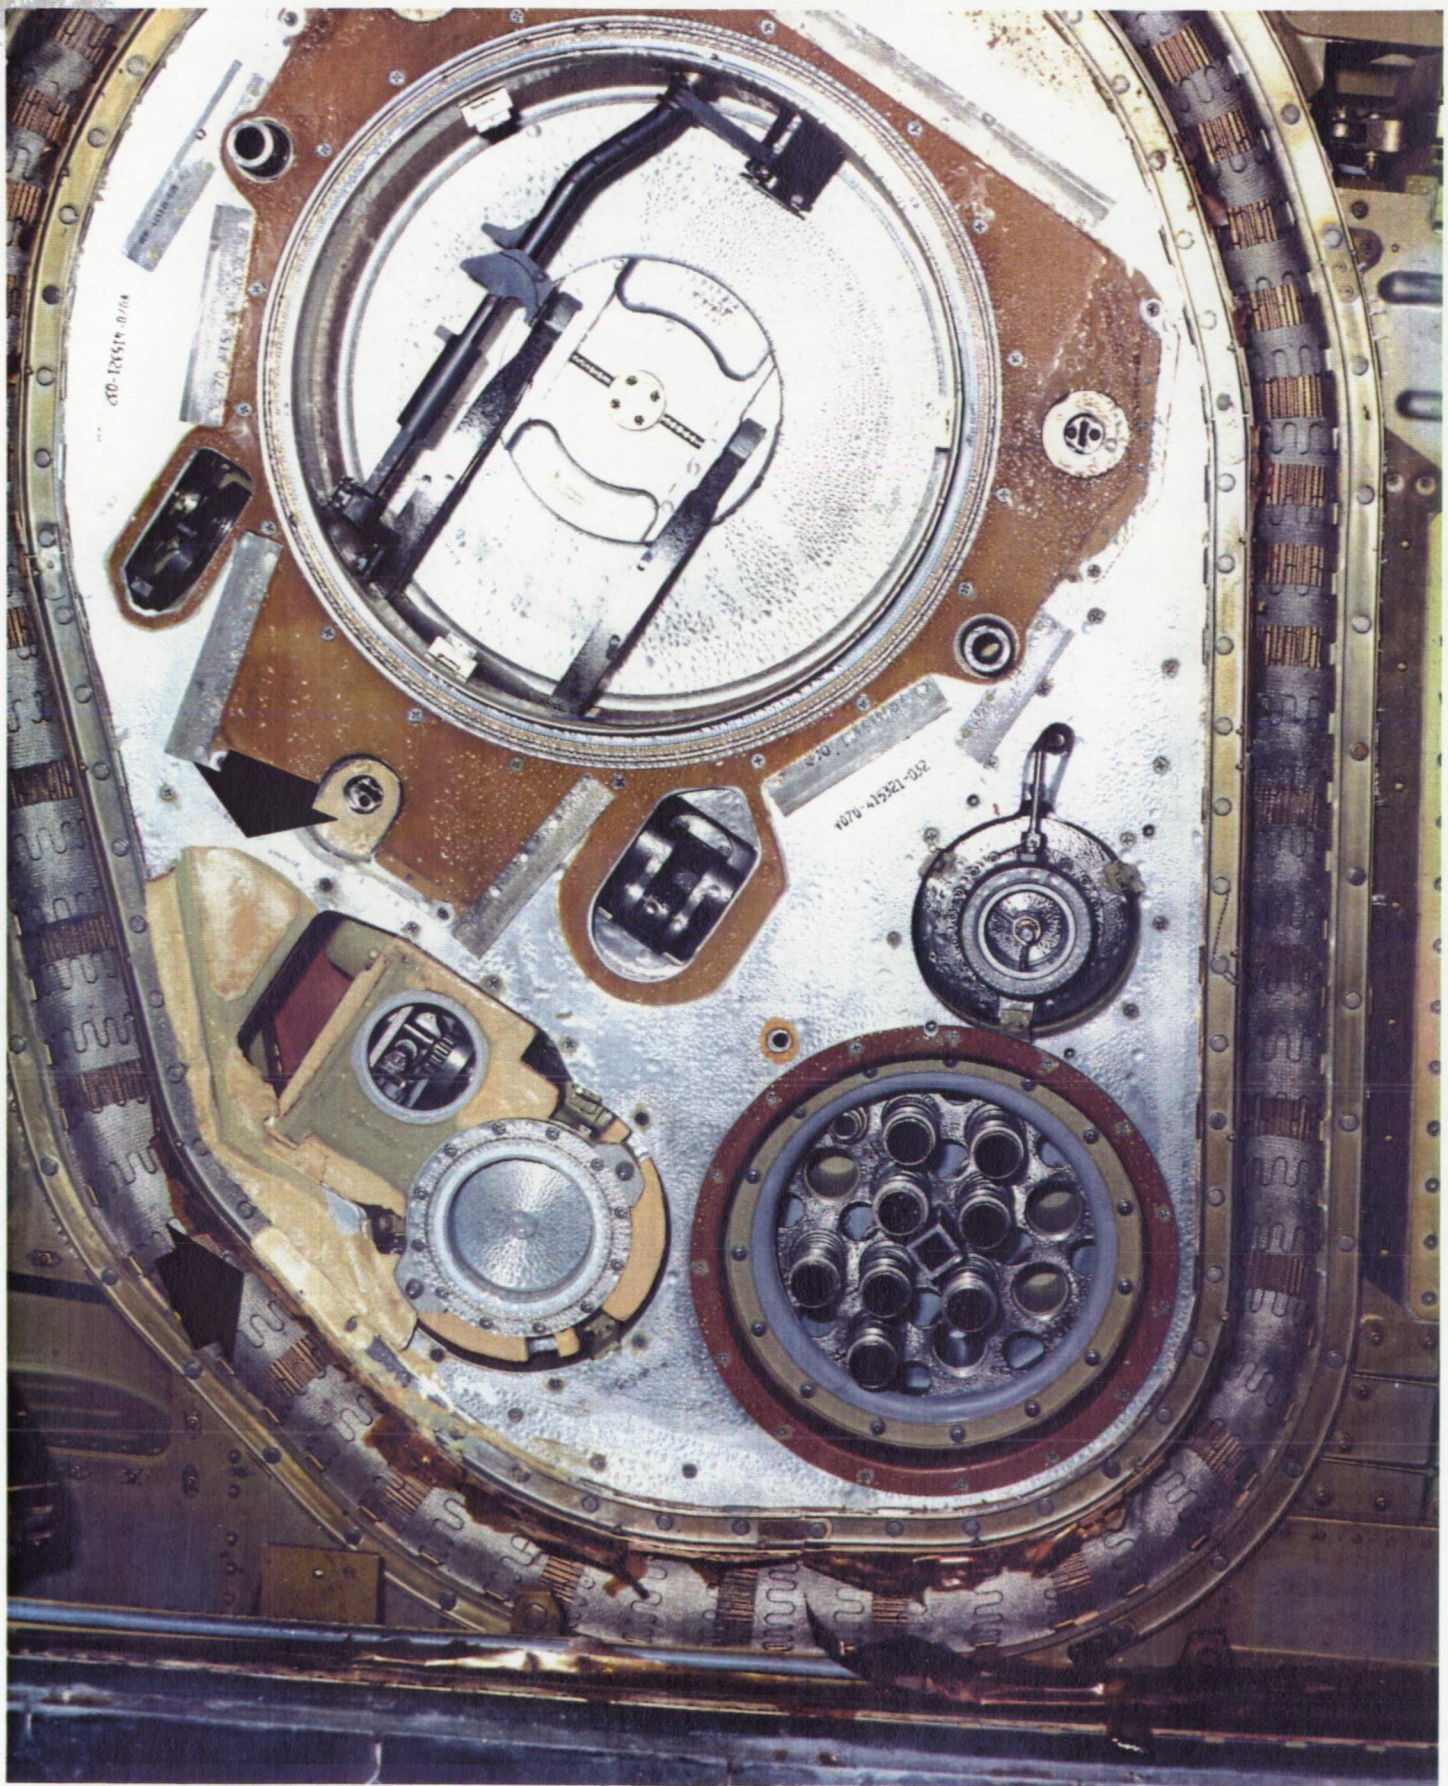
Overall view of the LH2 ET/ORB umbilical. All separation ordnance devices functioned properly. Note piece of umbilical foam adhering to the plate adjacent to the 4-inch disconnect.

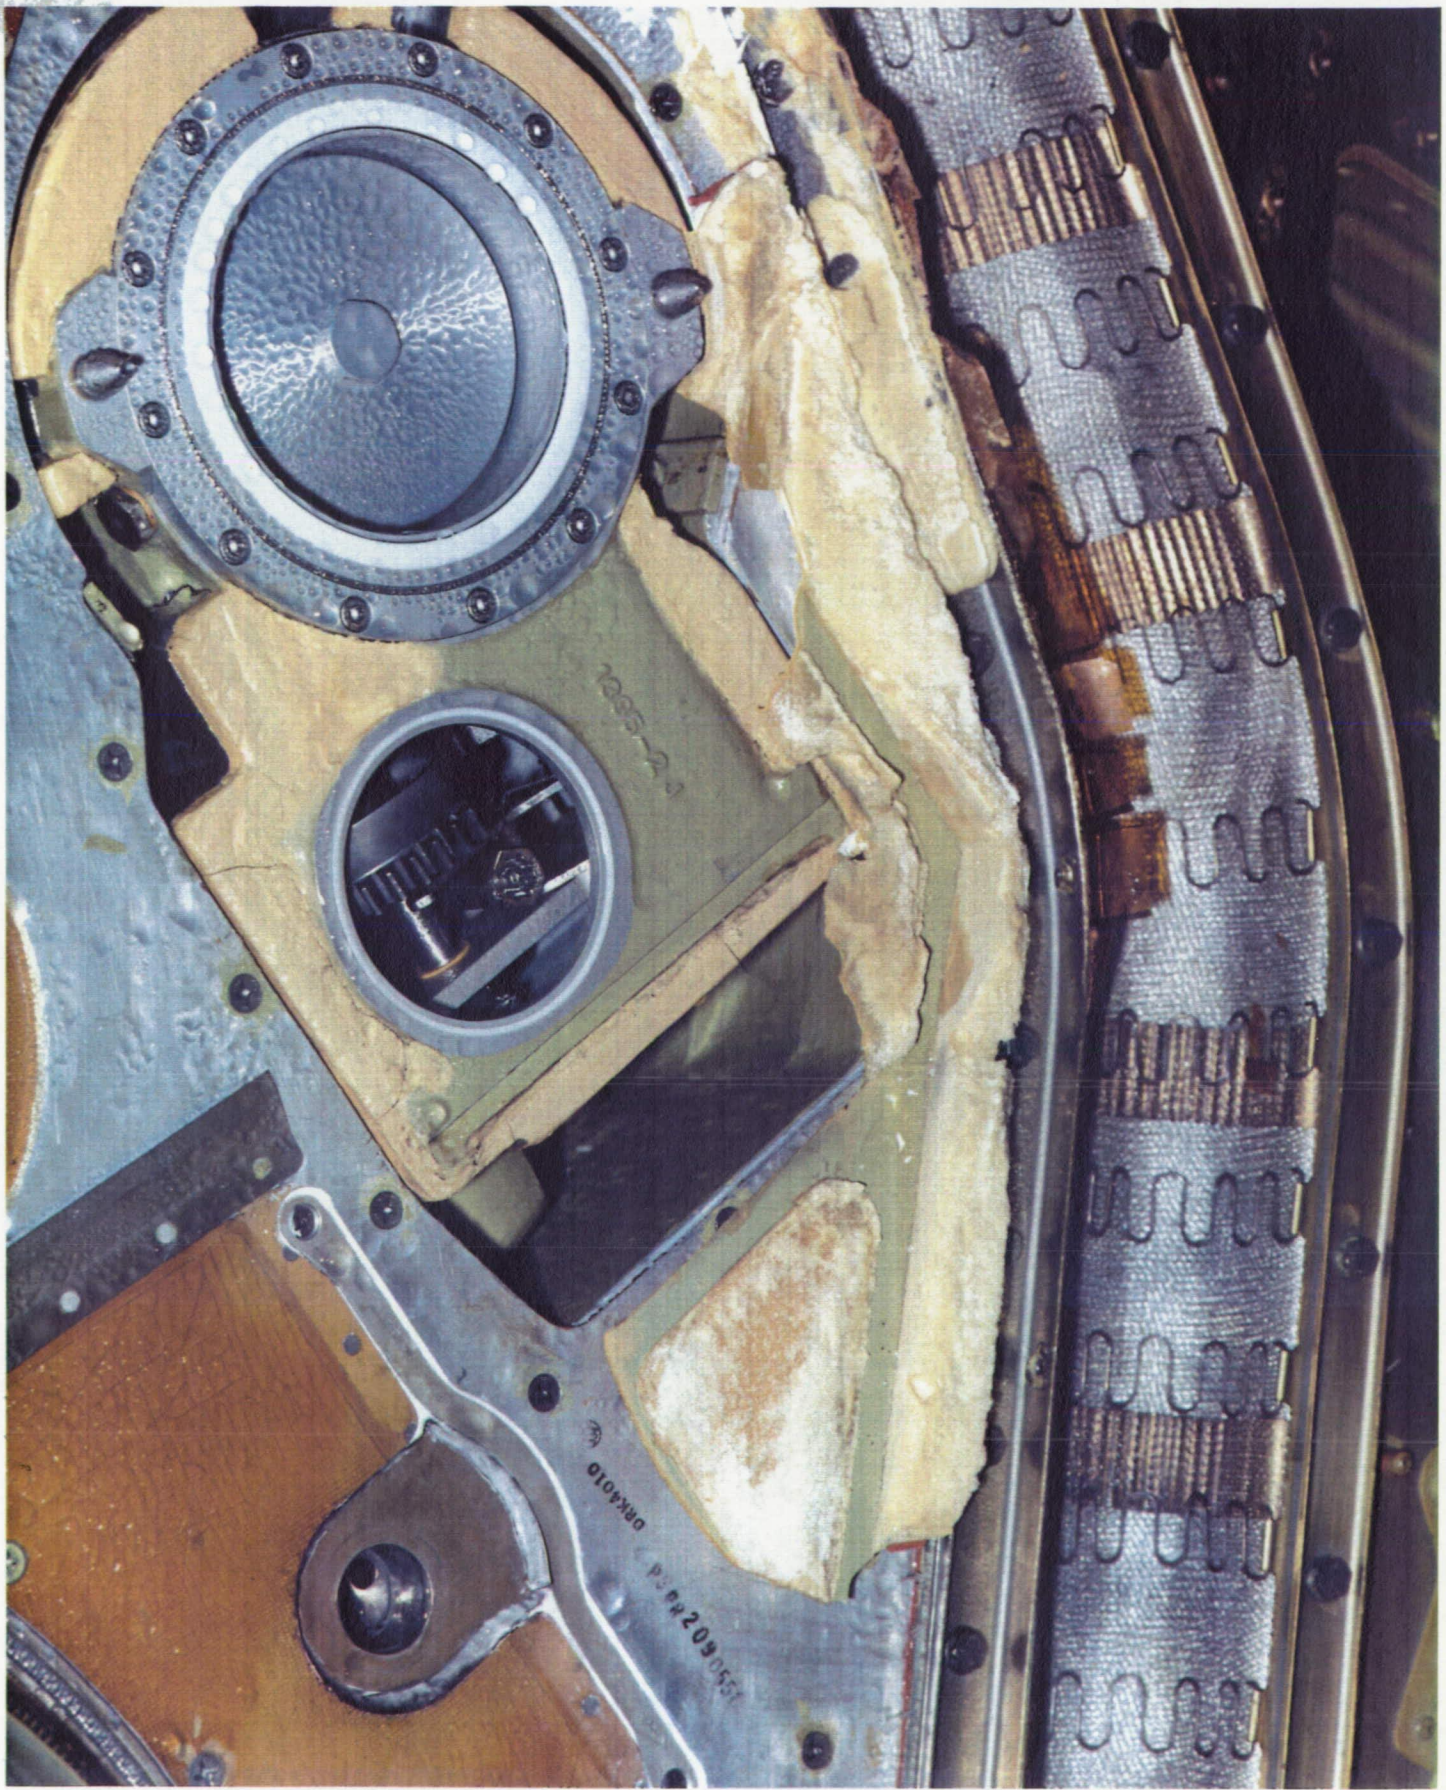
A 15-inch long piece of foam with red purge seal, which should have remained with the ET during separation, adhered to the LH2 ET/ORB umbilical near the 4-inch flapper valve.

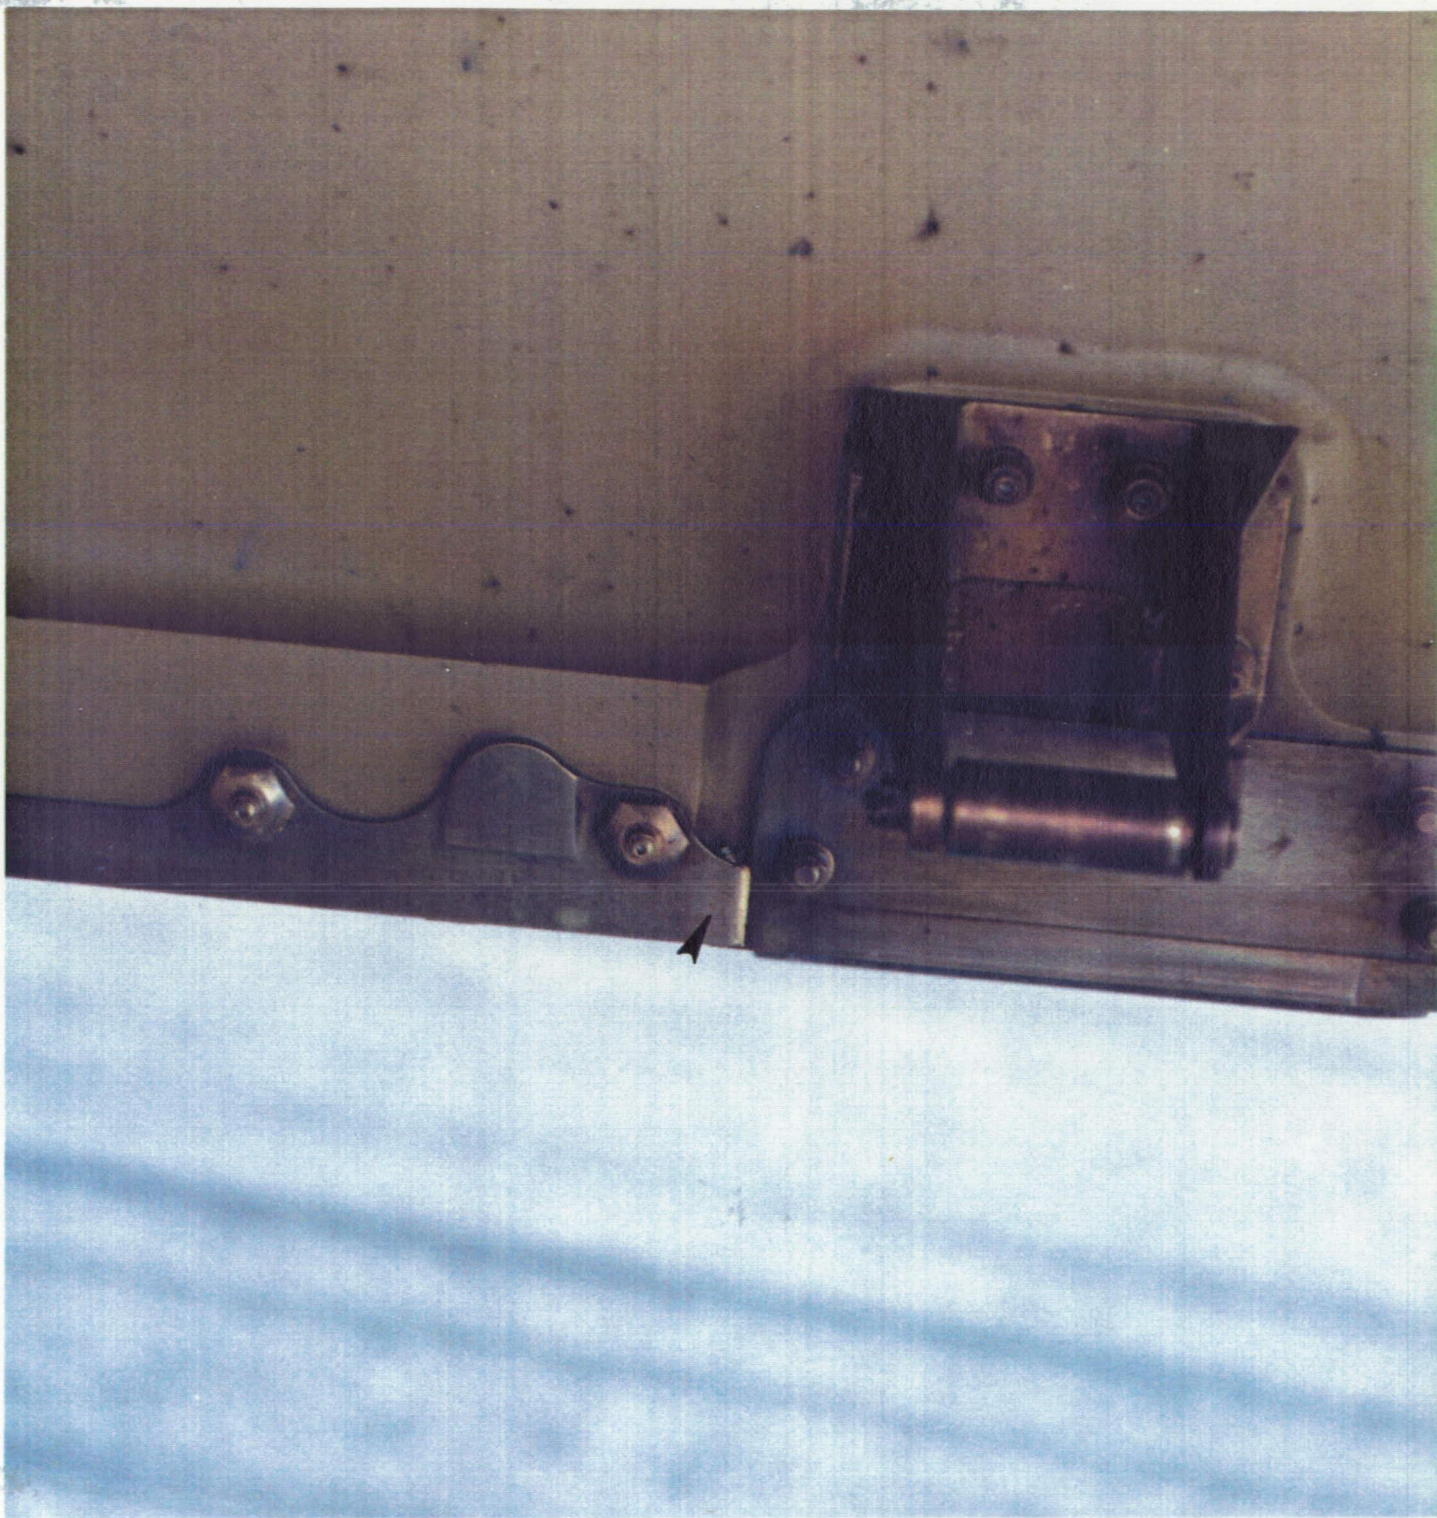
A small screw from the purge barrier retainer was found on the runway below the LH2 ET/ORB umbilical cavity. A nutplate with threads matching the screw, shown here, was wedged in a cavity on the left ET door.
